Report Summary

Report Overview

Well Built/Lacking Maintenance

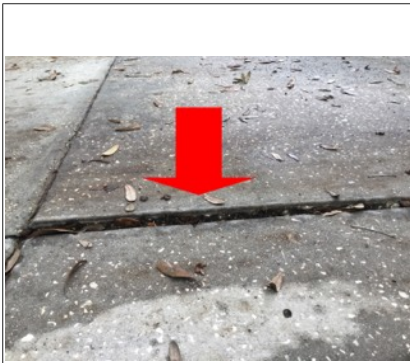
None Not Visible
Material Concrete Asphalt Gravel/Dirt Brick Other
Condition Satisfactory Marginal Poor Settling Cracks Typical cracks Pitched towards home
 Trip hazard Fill cracks and seal
Comments Drive way has over a 1/4 inch settlement lift in the left drive side

1/4 inch settlement lift on driveway

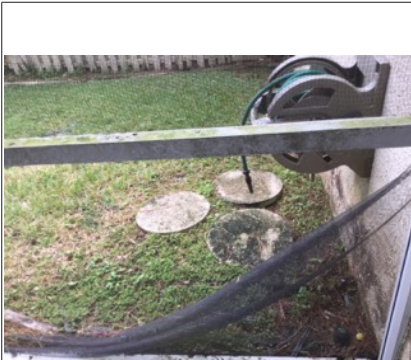
Comments Torn screen on right side

Torn screen on right side as you exit property

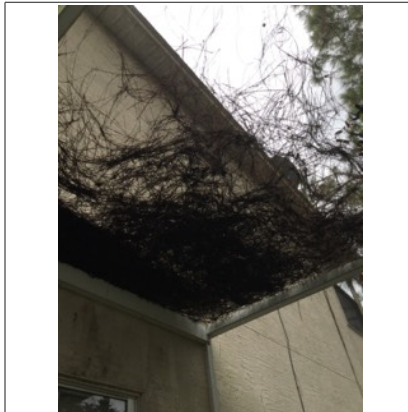
Pine needle build up on top of patio screen enclosure

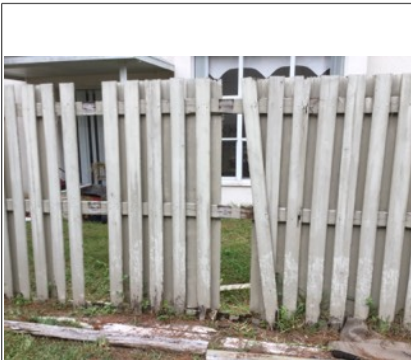
Comments Fence has some missing boards and wood deterioration

Missing Wood boards on the fence and some of the boards are deteriorating

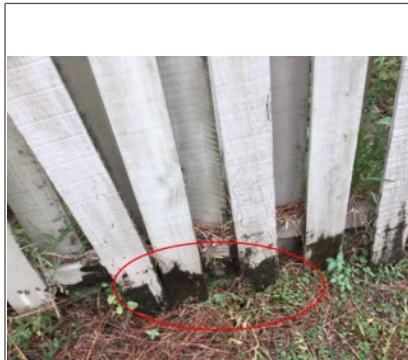
Wood deteriorating on the fence line

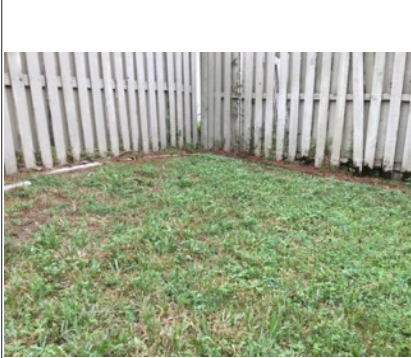
Comments Negative grade (Grade is sloped toward property in rear N/E corner of property also a tree branch encroaching roof line (rear of house).

Negative grade in rear N/E corner of property

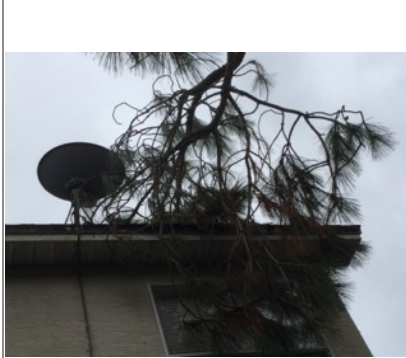
Tree branch encroaching rear roof line

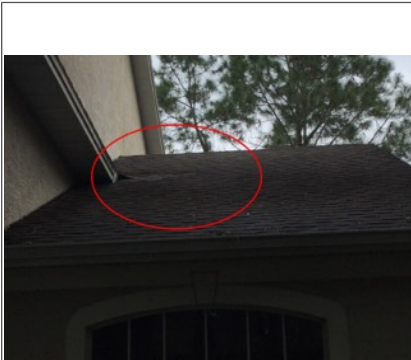
Granules are separating from shingles. There also appears to have been some roof repair work done on front right of roof.

Roof appears to have had some repair work done. Also some of the shingles are cupping.

Roof has approached end of life expectancy. Recommend professional roofing contractor evaluation.

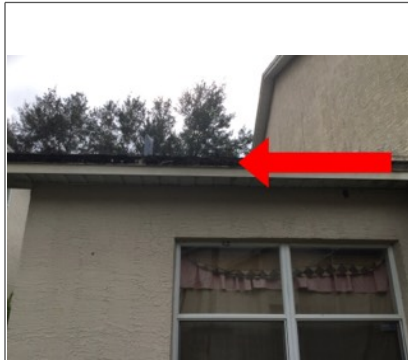
Shingle granules are beginning to separate

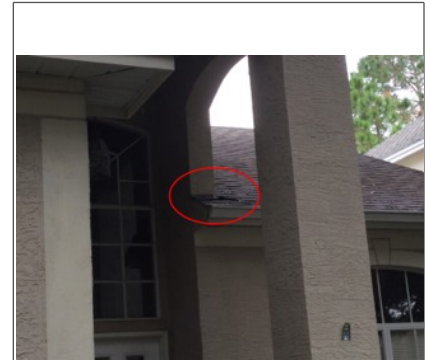
Pretty significant cupping of tiles. Evidence of leak (Dry Moisture Stains in Living Room)

Comments Roof has approached the end of its life expectancy also there at granule separation, cupping and what appears to be repair work.

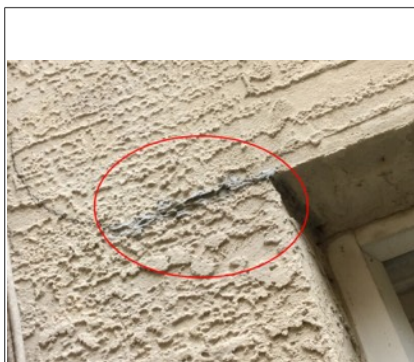
Crack above window (Laundry Room) needs to be sealed/caulked. Evidence of a leak inside property.

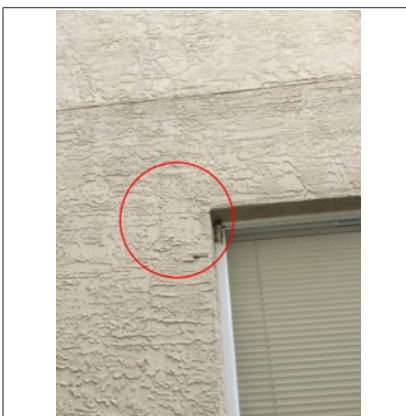
Crack side of window (Dining Area)

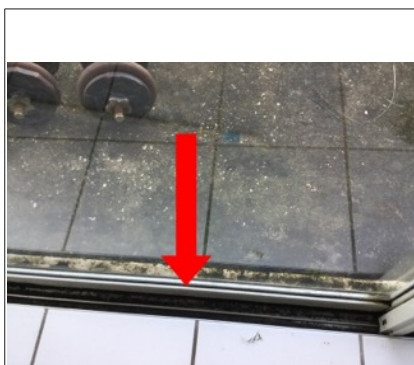
Clean sill plates as derbies is causing resistance as you go to open the sliding glass door.

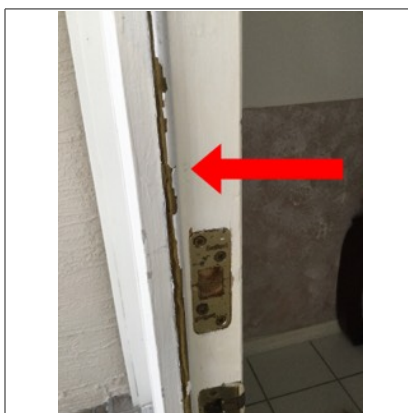
Weather Stripping on front door needs to be repaired/replaced

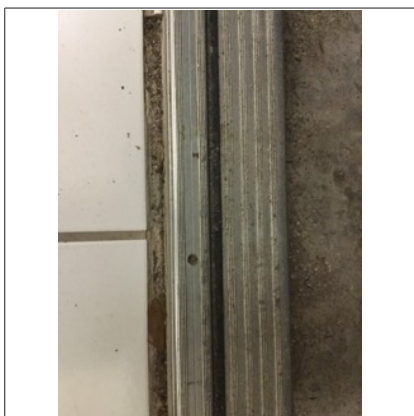
Slither of tile missing at sill plate

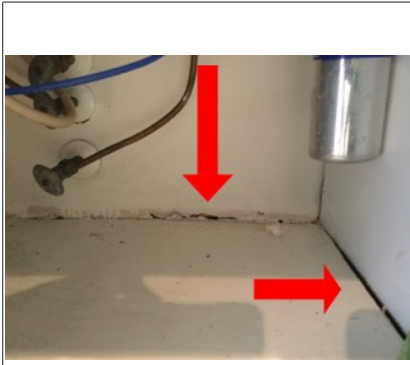
Dishwasher leaks
 Caulk cabinet under sink

Caulk cabinet under sink

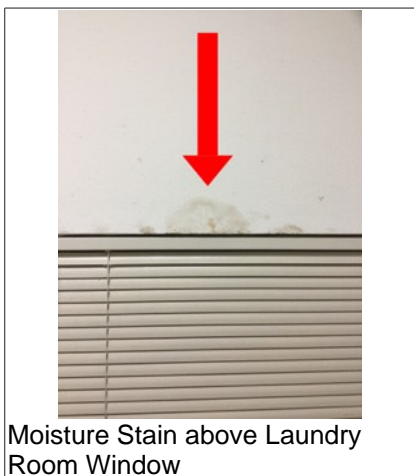
- Laundry sink** N/A
- Faucet leaks** Yes No
- Pipes leak** Yes No Not Visible
- Cross connections** Yes No Potential Safety Hazard
- Heat source present** Yes No
- Room vented** Yes No
- Dryer vented** N/A Wall Ceiling Floor Not vented Plastic dryer vent not recommended
 Not vented to exterior Recommend repair Safety hazard
- Electrical** Open ground/reverse polarity: Yes No Safety hazard
- GFCI present** Yes No Operable: Yes No Recommend GFCI Receptacles
- Appliances** Washer Dryer Water heater Furnace/Boiler
- Washer hook-up lines/valves** Satisfactory Leaking Corroded Not Visible
- Gas shut-off valve** N/A Yes No Cap Needed Safety hazard Not Visible
- Comments** Moisture stain above window in laundry room (79% Reading)

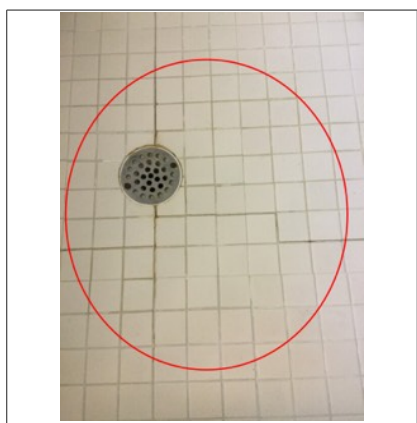
**Shower Base is cracked and leaking.
 Moisture is at 95% on drywall at bottom
 base of shower door.**

Evidence of moisture escaping from these cracks and Moisture reading on wall to the right of shower (Lower Corner where drywall is cracked) is at 95%.

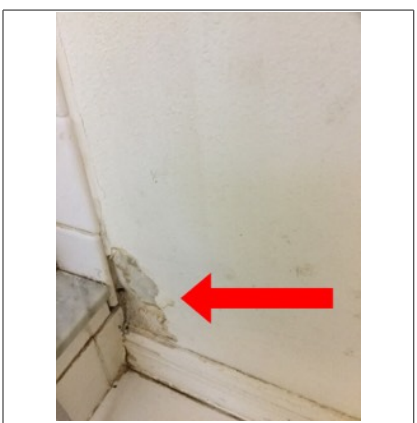
Moisture has caused this cracked drywall. Moisture reading at 95%

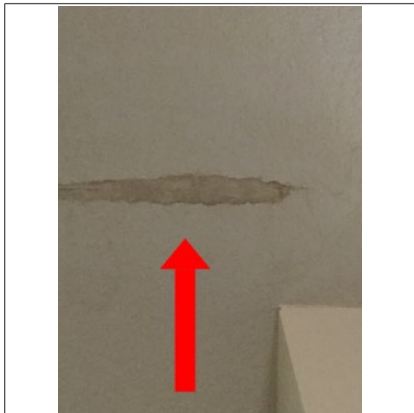
Ceiling just above Main Front Entrance to the Left and Moisture Stains Above Stair Well.

Moisture Stain on ceiling to the left of Main Front Entrance

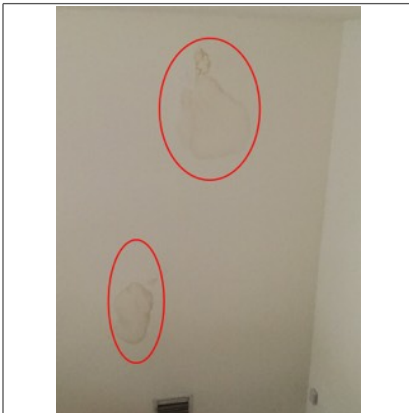
Multiple Moisture Stains above stair well

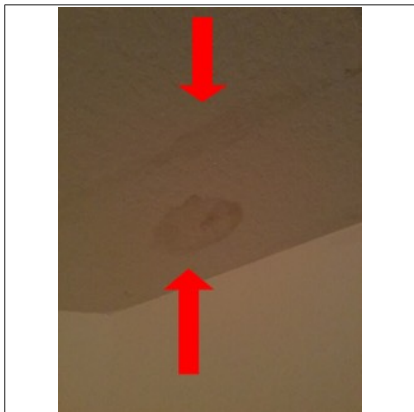
Moisture Stains on Ceiling to the left of Master Bedroom Entrance

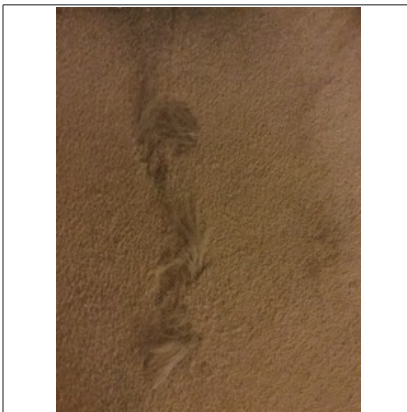
Torn carpet at entrance to Master Bedroom

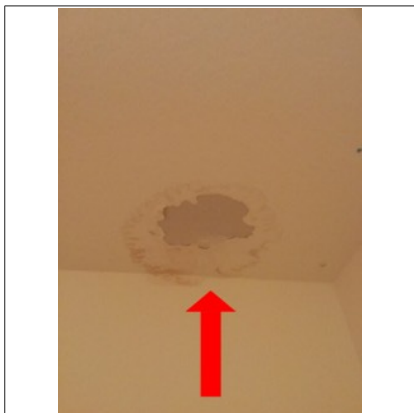
Moisture stain on ceiling in second bedroom
